**IN THE MATTER OF AN INVESTIGATION INTO A DEATH RELATED TO A  
MOTOR VEHICLE DRIVEN BY A WINNIPEG POLICE OFFICER**

**FINAL REPORT OF THE CIVILIAN DIRECTOR**  
**OF THE INDEPENDENT INVESTIGATION UNIT**

Acting Civilian Director:	Bruce M. Sychuk
IIU File Number:	2024-0047
Date of Release:	August 20, 2025

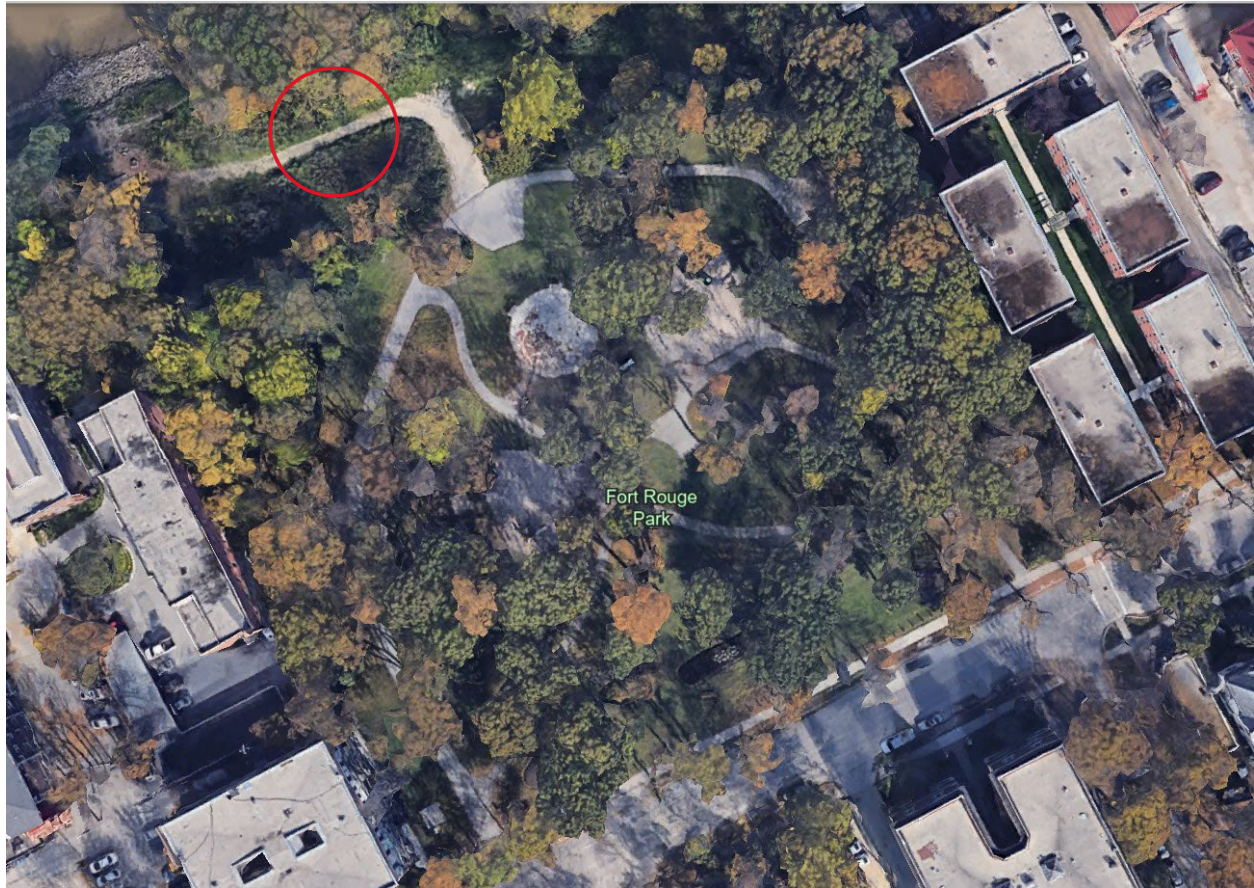
Below is a map of the area. The red-circled area is approximately where the collision occurred.

- The collision occurred in nighttime conditions.
- The area around the collision was dark and had no artificial light.
- The slope of the graveled access road started at a five per cent decline and was at a 10.3 per cent decline at the area of the collision.
- With the decreasing slope, it reduces visibility in front of the vehicle.
- The graveled access road also has a sharp left turn while on the downward slope.
- The driver's side pillar is also a contributing factor in the line of sight.
- There is no expectation of a pedestrian laying down on the graveled access road.

- The driver did not see the pedestrian because visibility was a factor in this collision.
- The fact that there was no artificial lighting to light up the surrounding areas is another factor.
- The debris that was left on the side of the graveled access road is distracting, when it is illuminated by the vehicle's headlights, because it focuses your attention and reduces your night vision.

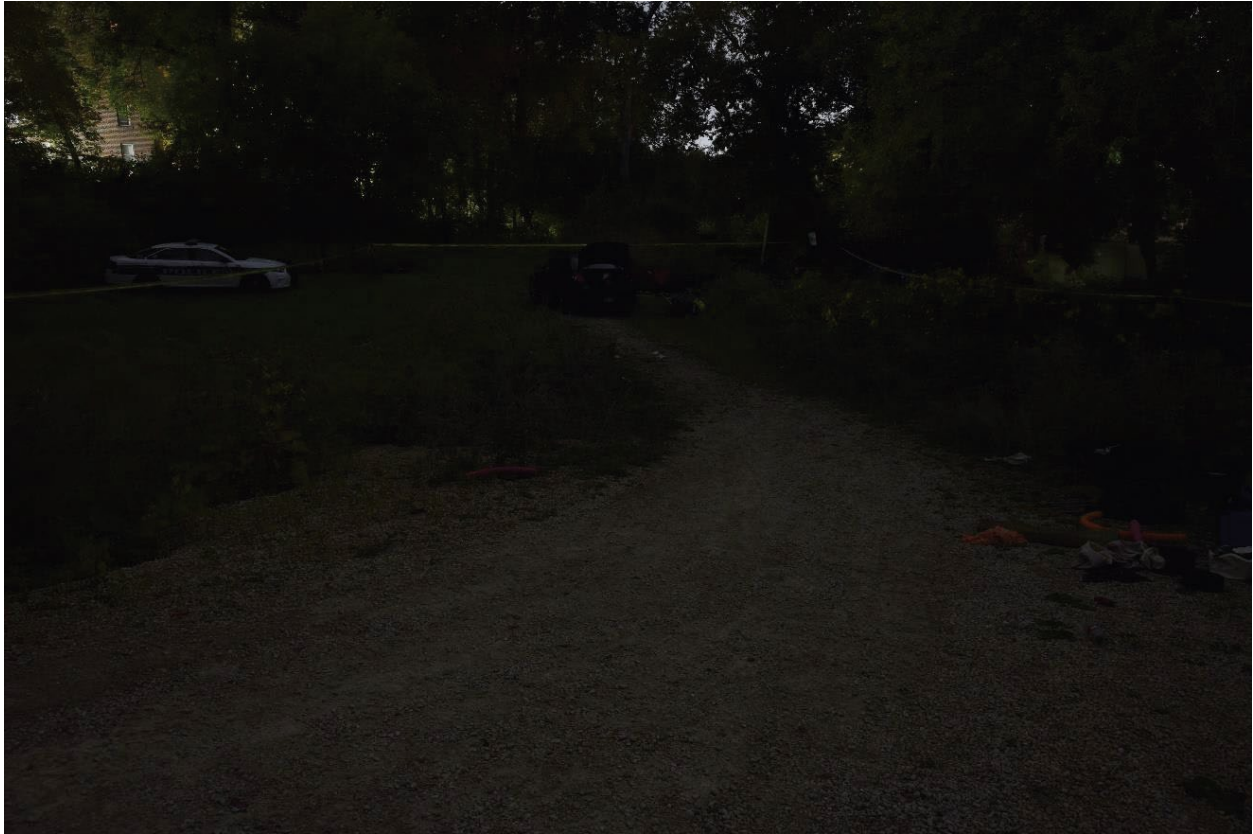
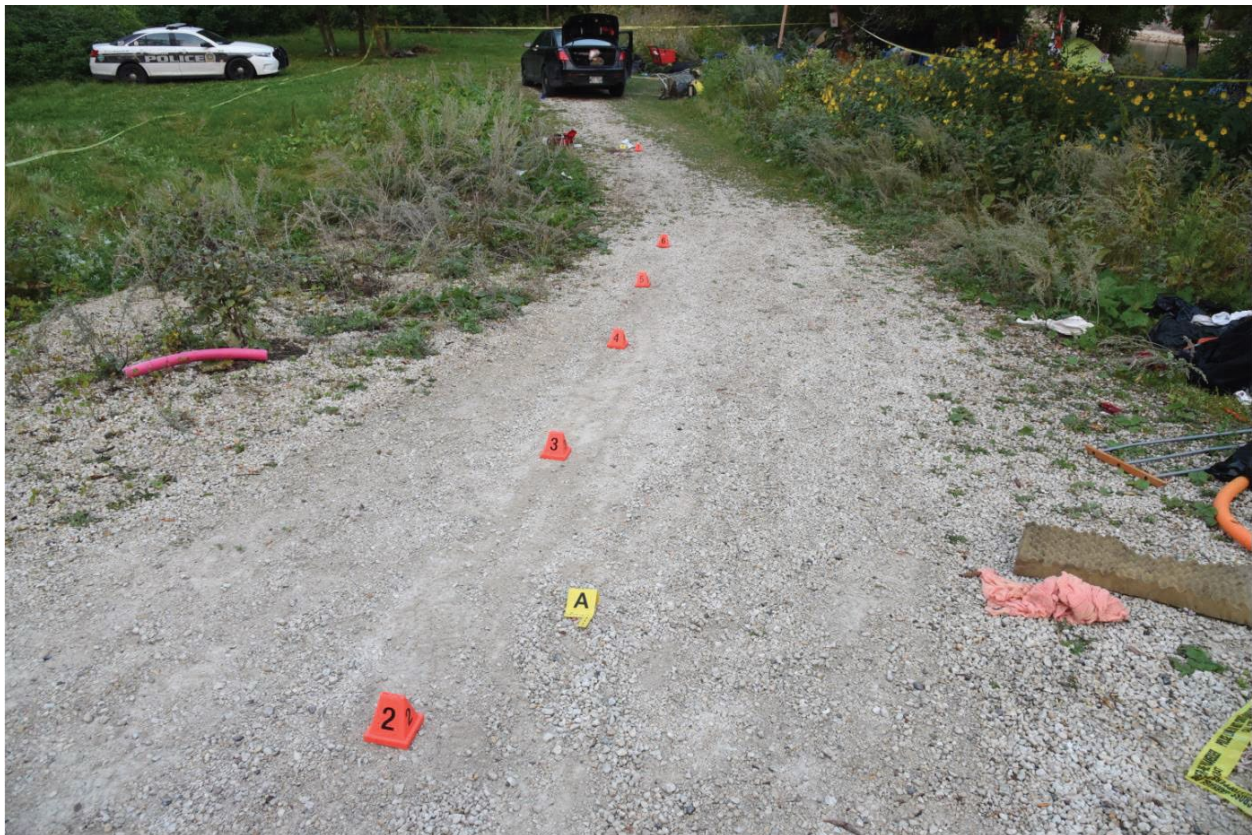
Above is a photo taken for the traffic analyst's report at a similar time of night as the collision. Below is the exact same photo taken during the day.
